**JOHNSON CONTROLS, INC.
FOWLERVILLE, MI
EPA ID NO. MID099124299**

**FIELD OVERSIGHT REPORT
FOR PHASE III RFI FIELD ACTIVITIES**

FIELD OVERSIGHT REPORT
FOR PHASE III RFI FIELD ACTIVITIES

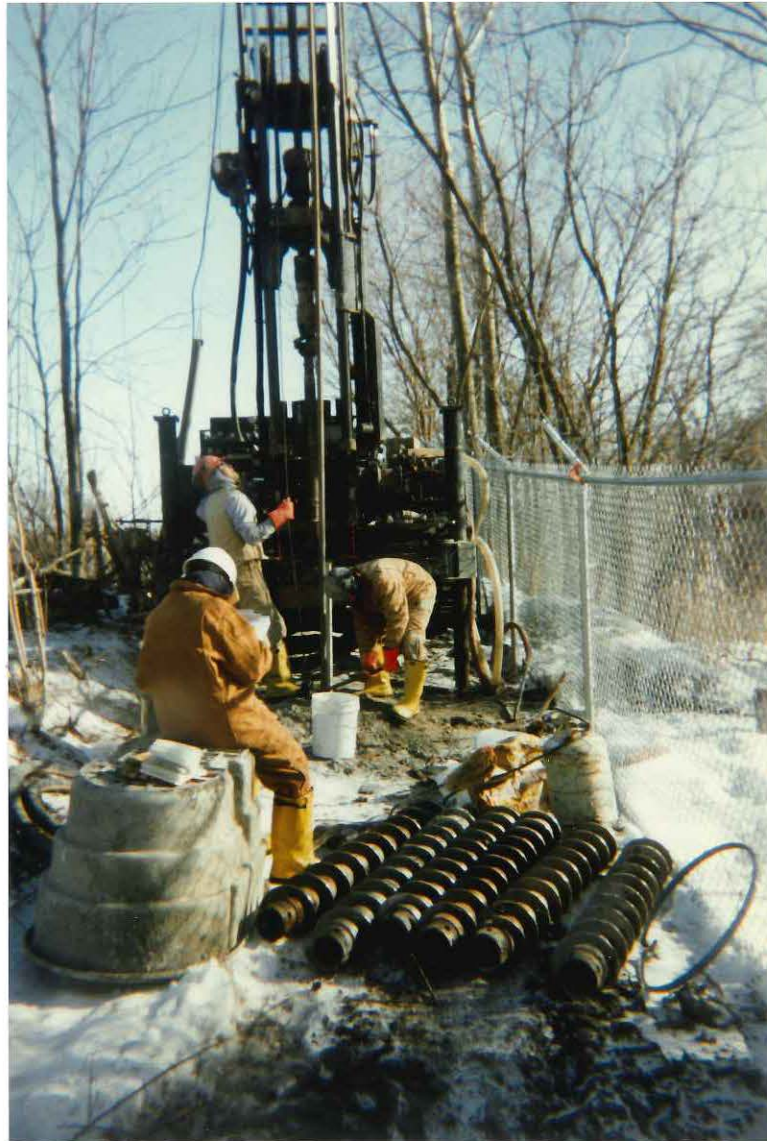
PHOTOGRAPH #38

LOCATION:	Stanley Tools, Fowlerville, MI
DATE:	1/26/94
TIME:	1430
SUBJECT:	Drilling of MW-F5 (Intermediate Well).

On January 26, M&E observed the drilling, installation and completion of the intermediate monitoring well MW-F5, installed to a depth of 30 feet. This work was performed by Christina Oehl of Dames & Moore and by members of Stearns Drilling Company using one drill rig. The grid soil sampling was performed by Bill Eckhoff and Stearns Drilling Company using a second drill rig at locations GB-29 through GB-32 north of Area F. An additional grid boring sample was obtained by Christina Oehl and Stearns Drilling Company at GB-72. M&E also observed Bill Eckhoff and Stearns Drilling Company obtain rinse blank samples.

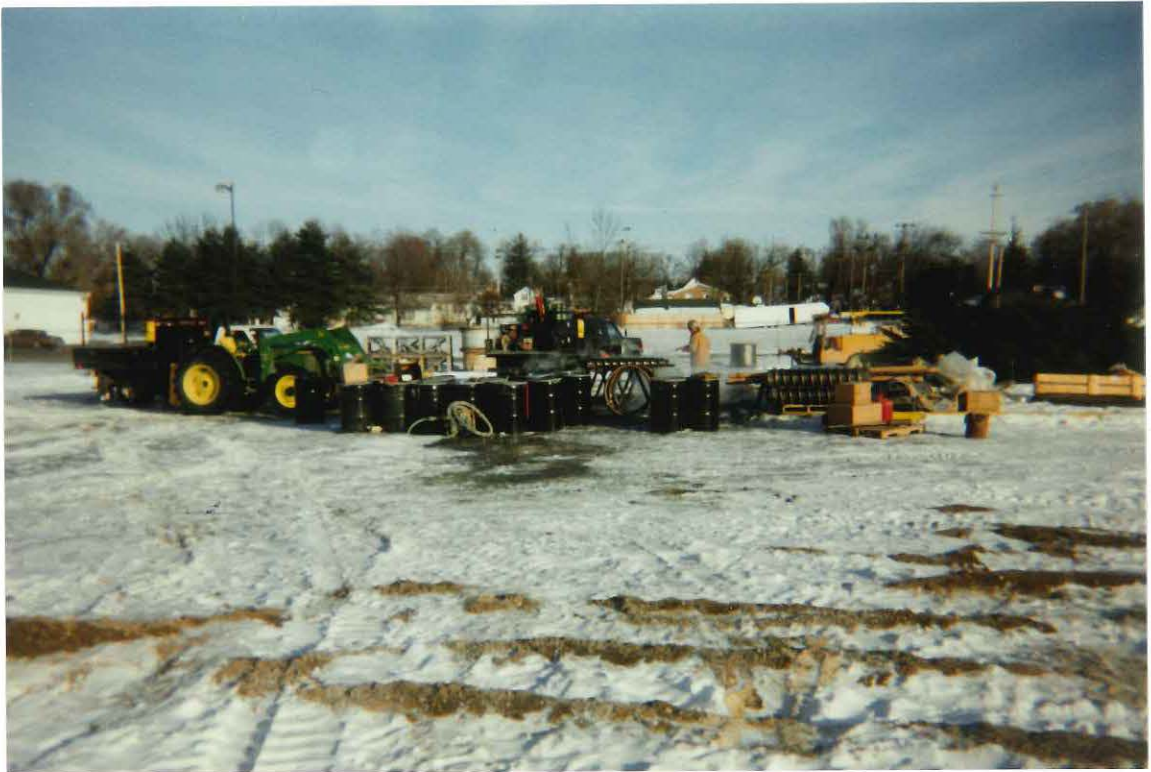
PHOTOGRAPH #40

LOCATION:	Stanley Tools, Fowlerville, MI
DATE:	1/26/94
TIME:	1600
SUBJECT:	Decon of augers and drilling equipment.

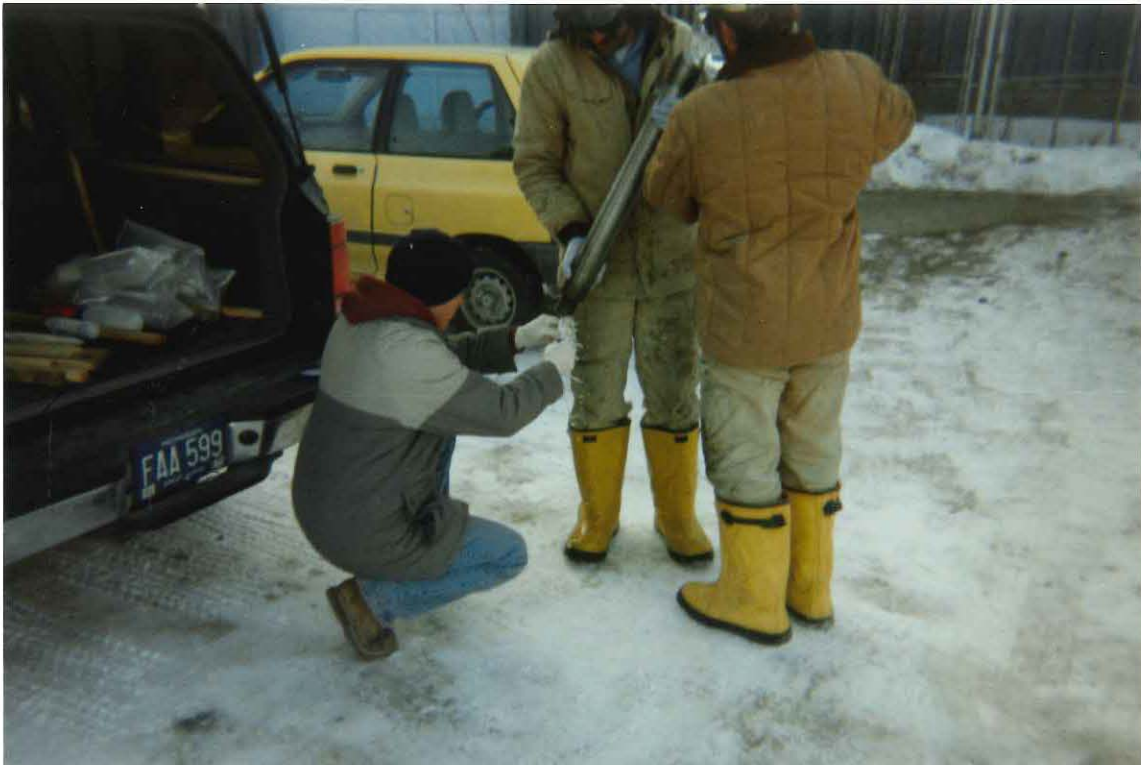
PHOTOGRAPH #41

LOCATION:	Stanley Tools, Fowlerville, MI
DATE:	1/26/94
TIME:	1430
SUBJECT:	Dames & Moore taking an equipment blank.

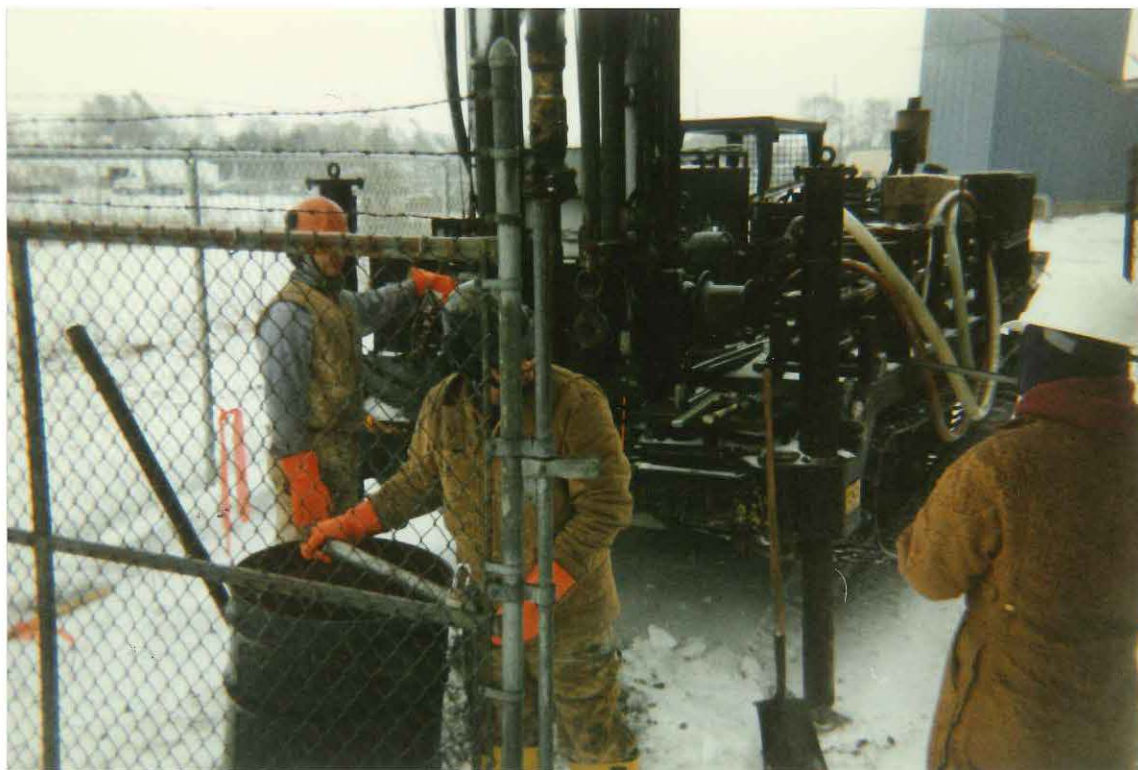
PHOTOGRAPH #42

LOCATION:	Stanley Tools, Fowlerville, MI
DATE:	1/27/94
TIME:	1430
SUBJECT:	Sampling at GB-69.

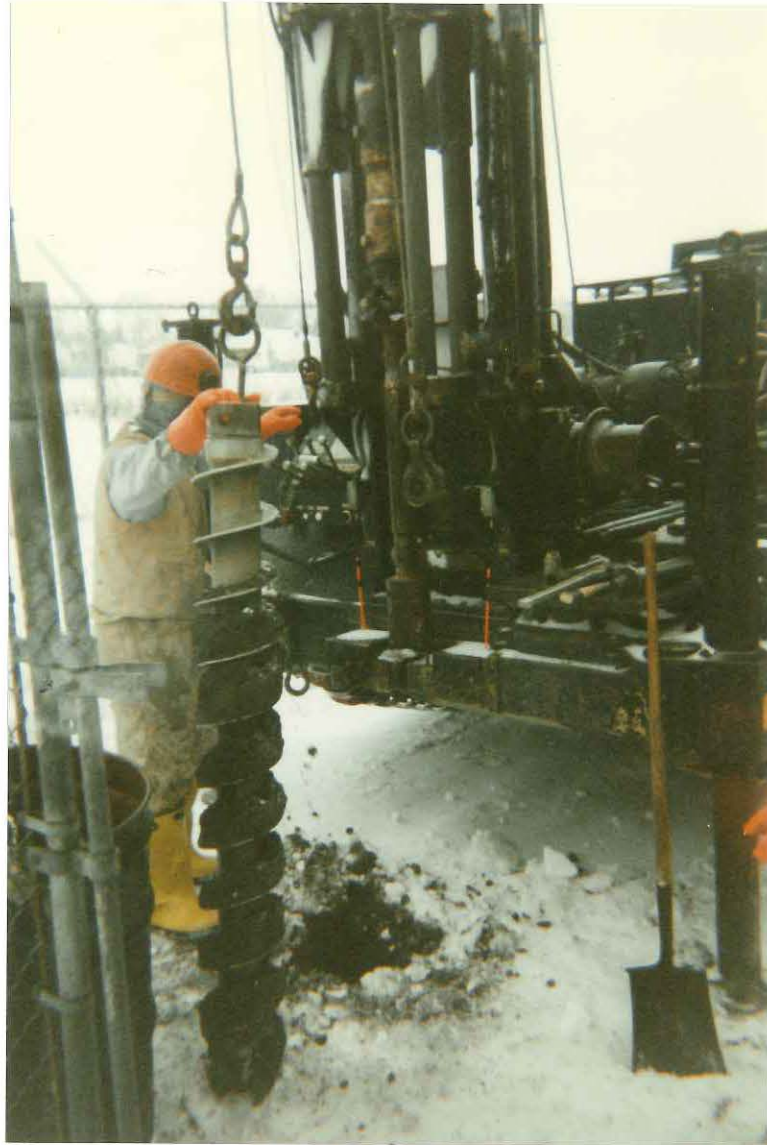
PHOTOGRAPH #43

LOCATION:	Stanley Tools, Fowlerville, MI
DATE:	1/27/94
TIME:	1430
SUBJECT:	Sampling at GB-69.

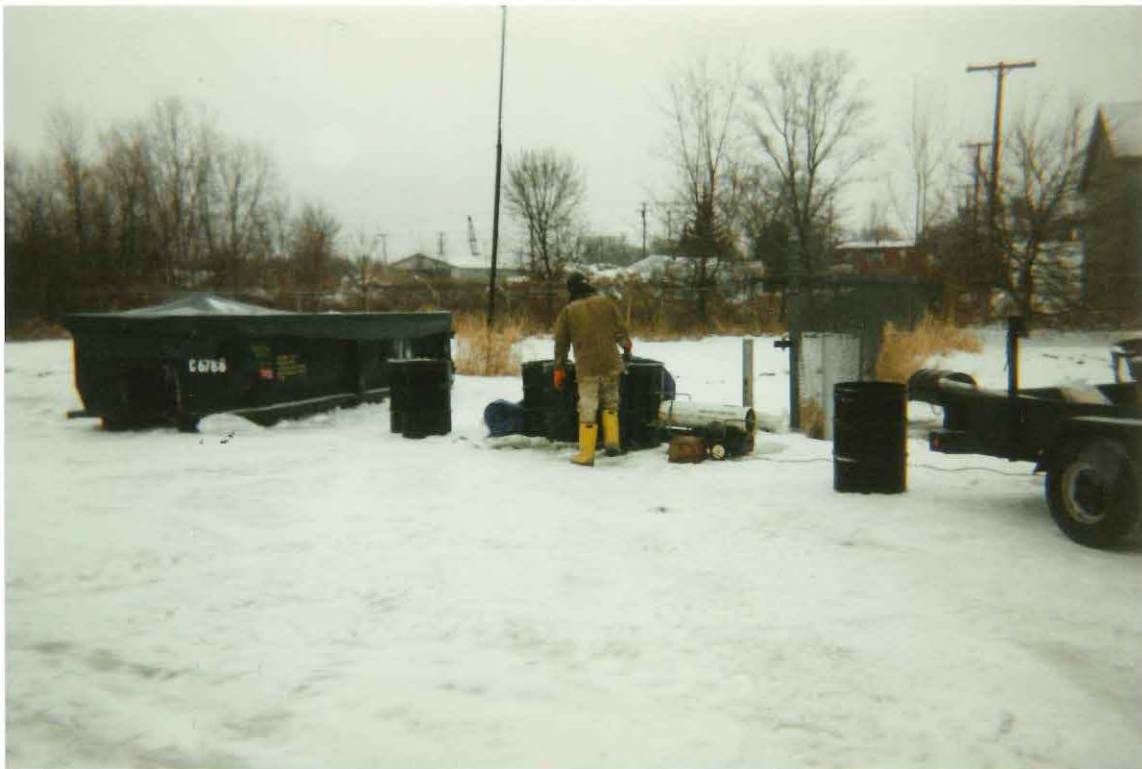
PHOTOGRAPH #44

LOCATION:	Stanley Tools, Fowlerville, MI
DATE:	1/27/94
TIME:	1500
SUBJECT:	Drillers emptying drums into roll-off.

Most of the soil sampling and monitoring well installation work was suspended on January 27 because of adverse weather conditions, but repair of decontamination equipment, melting and emptying of soil barrels into roll-off boxes, decontamination, mobilization and setting up of drill rigs was performed. Paper work was performed by Bill Eckhoff of Dames & Moore. One soils boring sample at location GB-69 was obtained by Bill Eckhoff and Stearns Drilling Company.

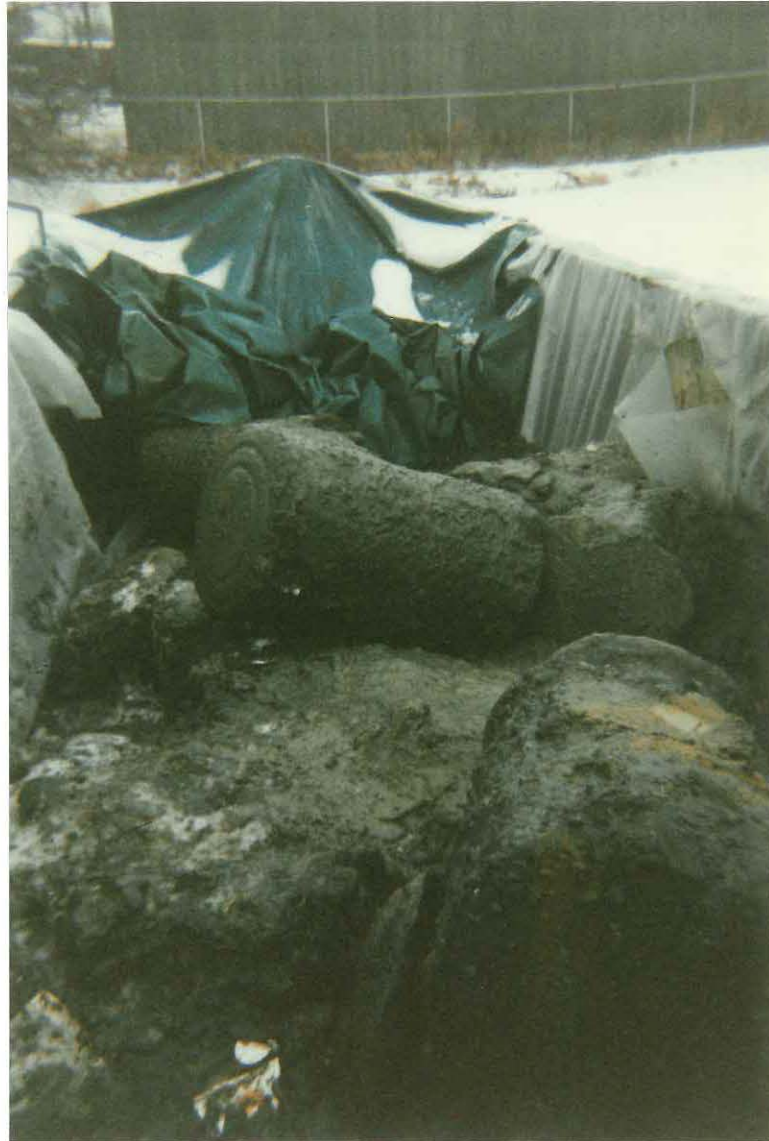
PHOTOGRAPH #45

LOCATION:	Stanley Tools, Fowlerville, MI
DATE:	1/27/94
TIME:	1500
SUBJECT:	Emptied material in roll-offs.

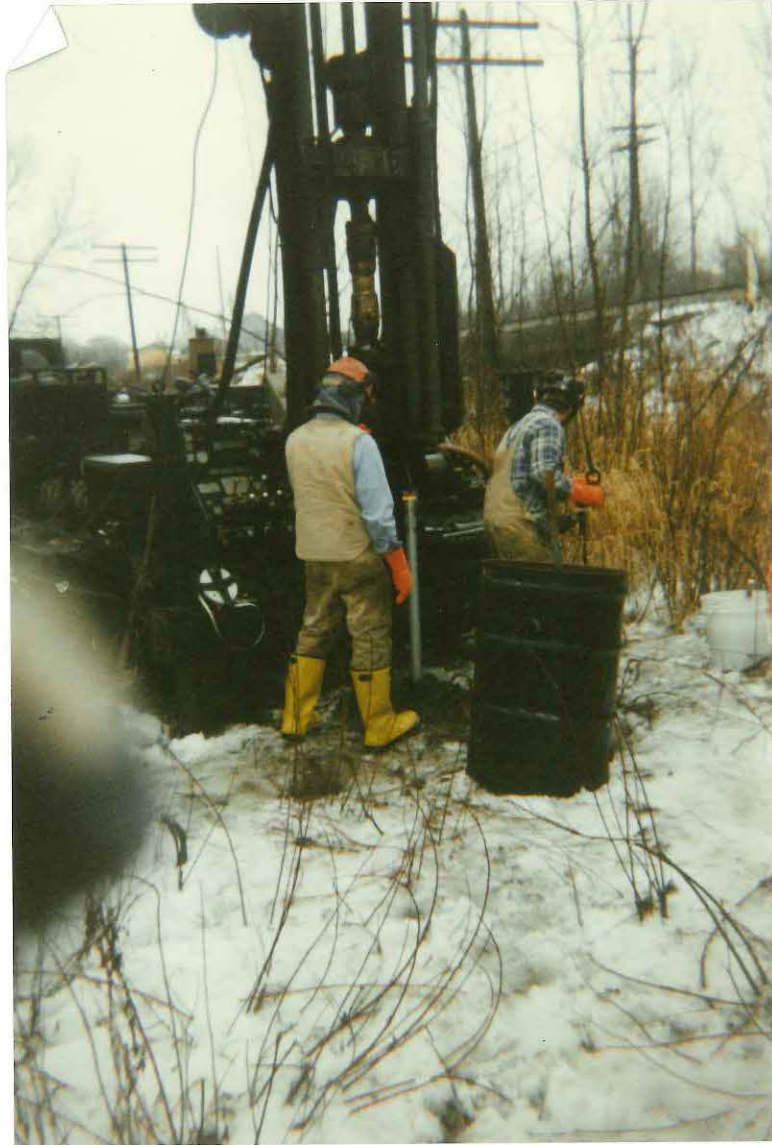
PHOTOGRAPH #46

LOCATION:	Stanley Tools, Fowlerville, MI
DATE:	1/28/94
TIME:	1215
SUBJECT:	Installing off-site well MW-053.

On January 28, M&E observed the drilling, installation and completion of the three off-site monitoring wells that are adjacent to the Red Cedar River. The wells MW-OS1 through MW-OS3 were drilled and installed to a shallow depth of ten feet with the same construction at all three wells. This work was performed by Christina Oehl and by members of Stearns Drilling Company. The grid soil sampling continued with samples obtained at locations GB-33 through GB-37 and at GB-11, located north of Area A. A matrix spike and a matrix spike duplicate

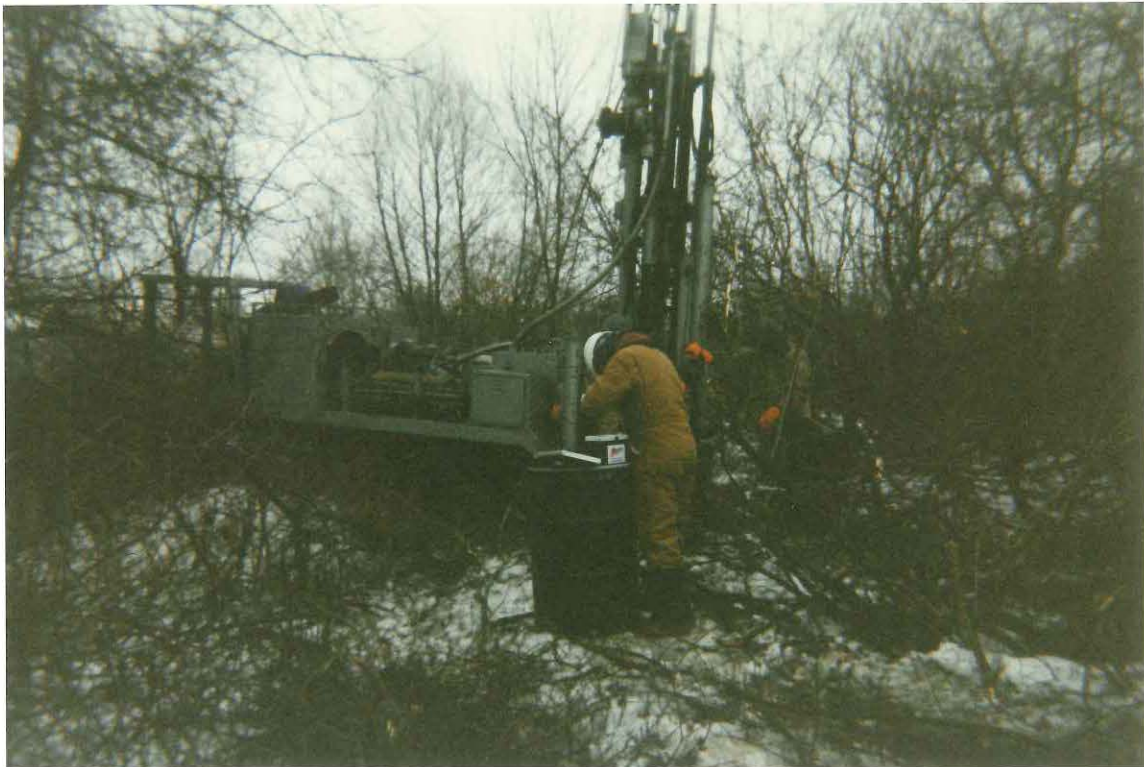
PHOTOGRAPH #47

LOCATION:	Stanley Tools, Fowlerville, MI
DATE:	1/28/94
TIME:	1540
SUBJECT:	Sampling of GB-11.

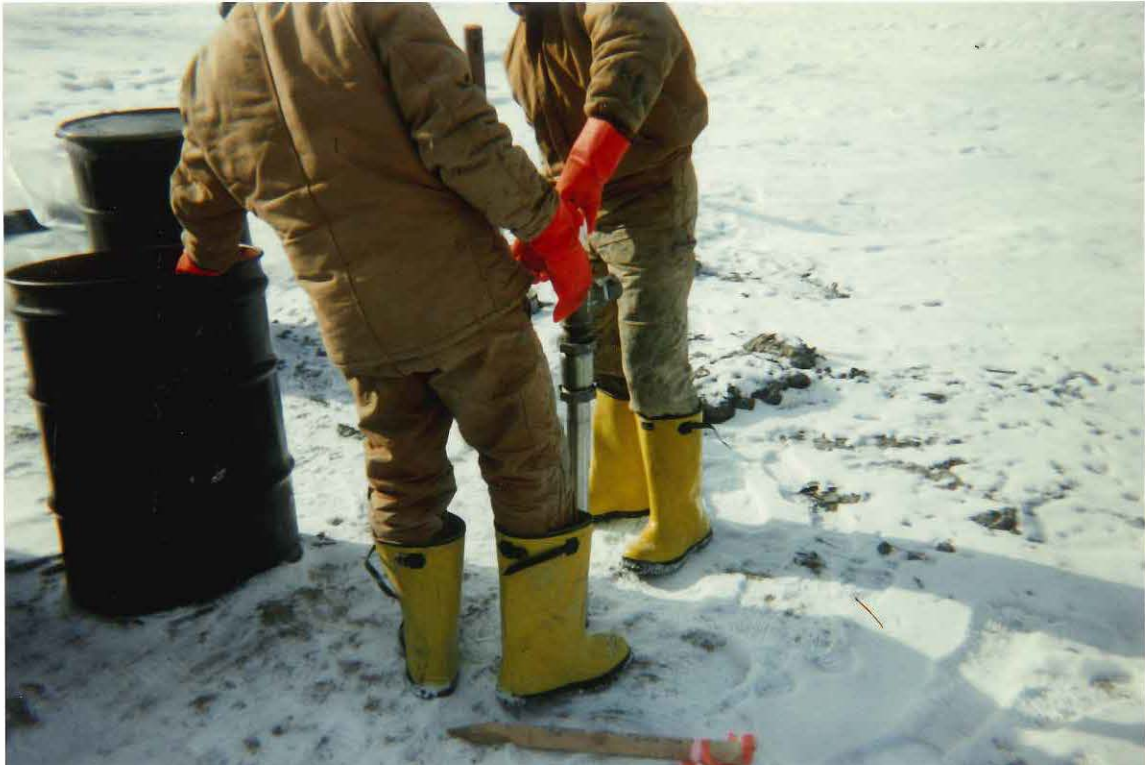
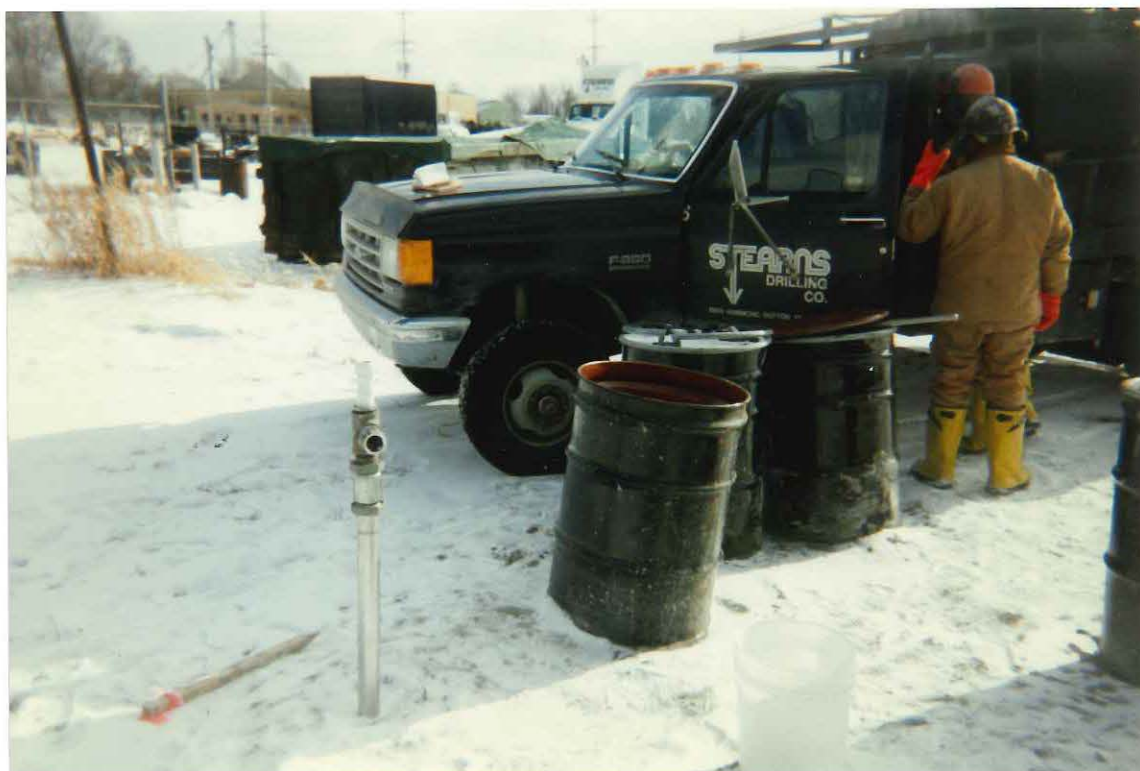
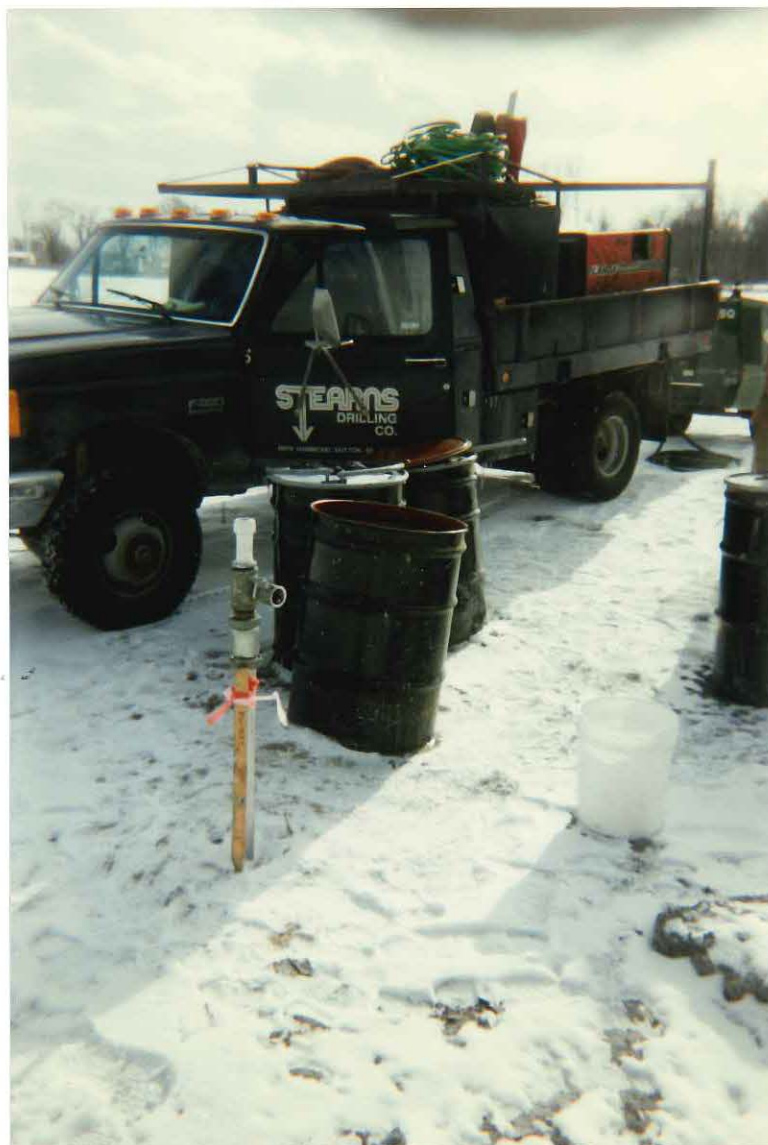
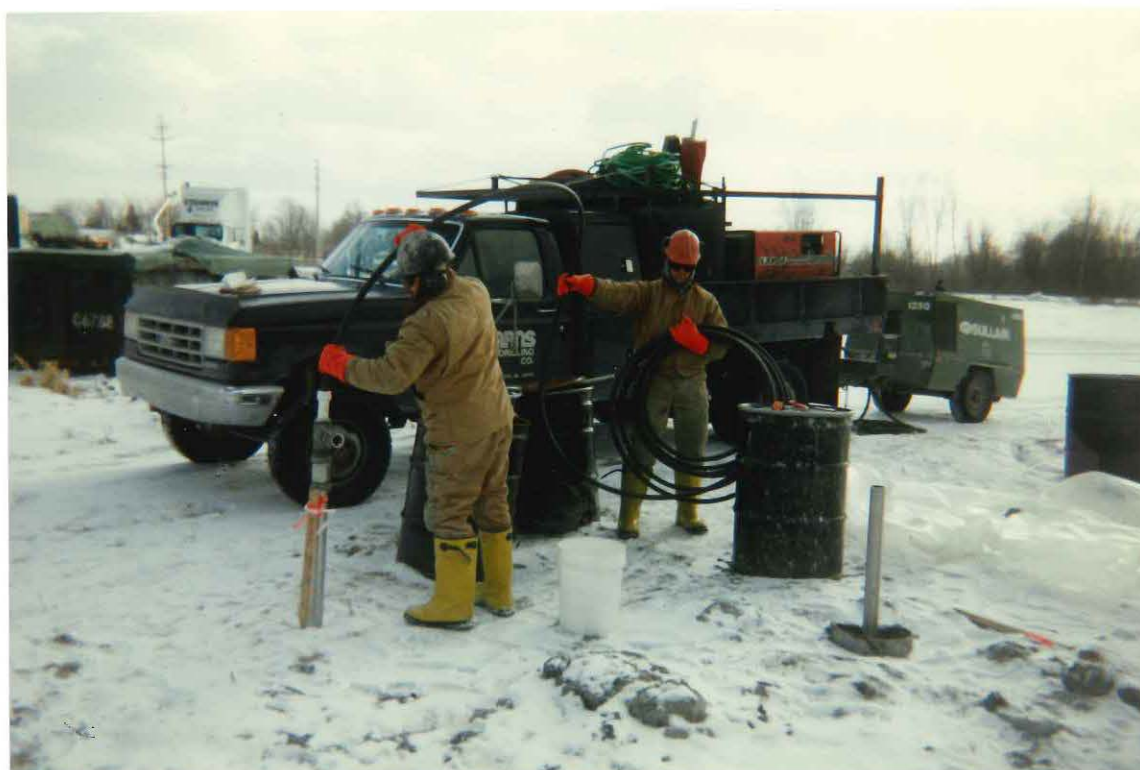
LOCATION:	Stanley Tools, Fowlerville, MI
DATE:	2/1/94
TIME:	1448
SUBJECT:	Setting up to air surge MW-BCK1 (shallow well).

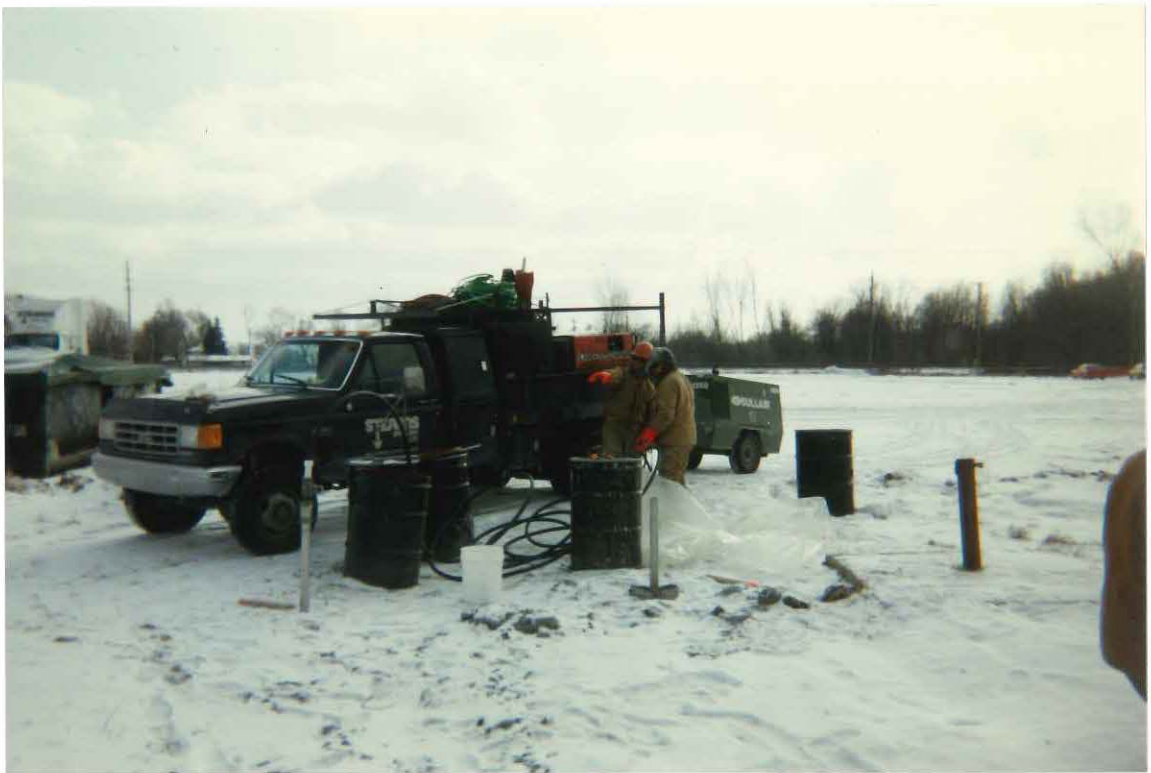
PHOTOGRAPH #52

LOCATION:	Stanley Tools, Fowlerville, MI
DATE:	2/1/94
TIME:	1451
SUBJECT:	Setting up to air surge MW-BCK1 (shallow well).

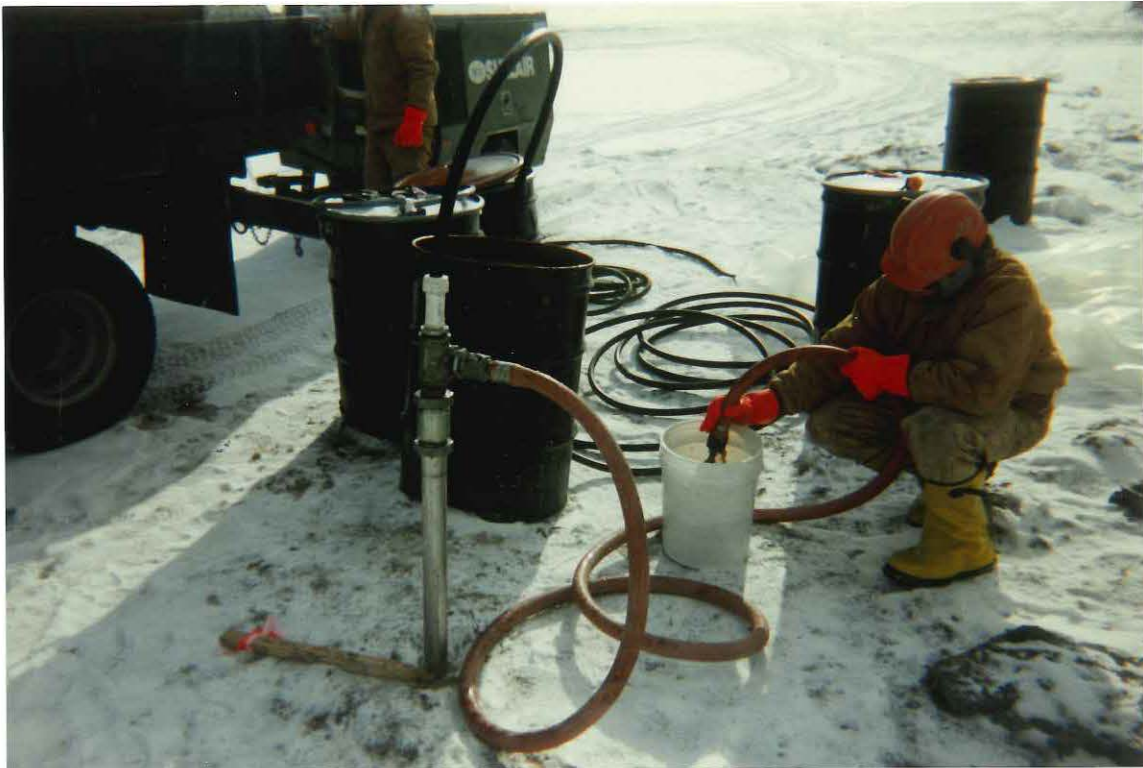
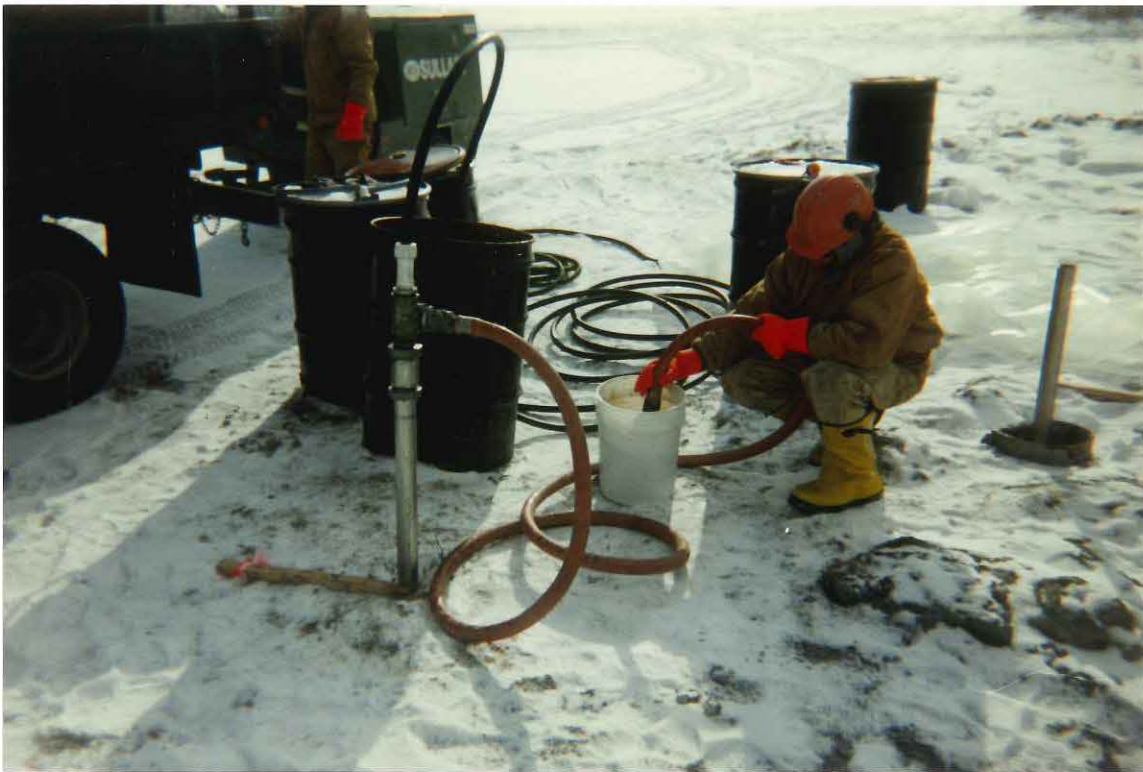
PHOTOGRAPH #54

LOCATION:	Stanley Tools, Fowlerville, MI
DATE:	2/1/94
TIME:	1505
SUBJECT:	Developing MW-BCK1 (shallow well).

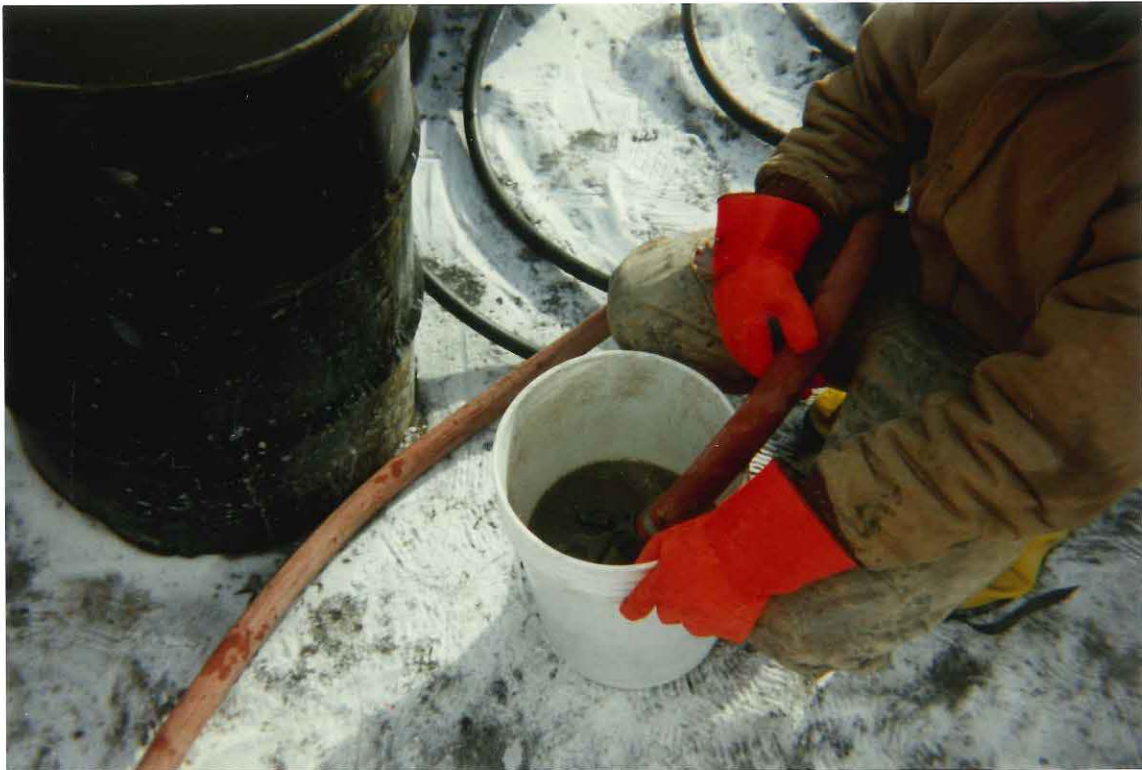
PHOTOGRAPH #56

LOCATION:	Stanley Tools, Fowlerville, MI
DATE:	2/1/94
TIME:	1505
SUBJECT:	Murky development water after 20-25 gallons - MW-BCK1 (shallow well).

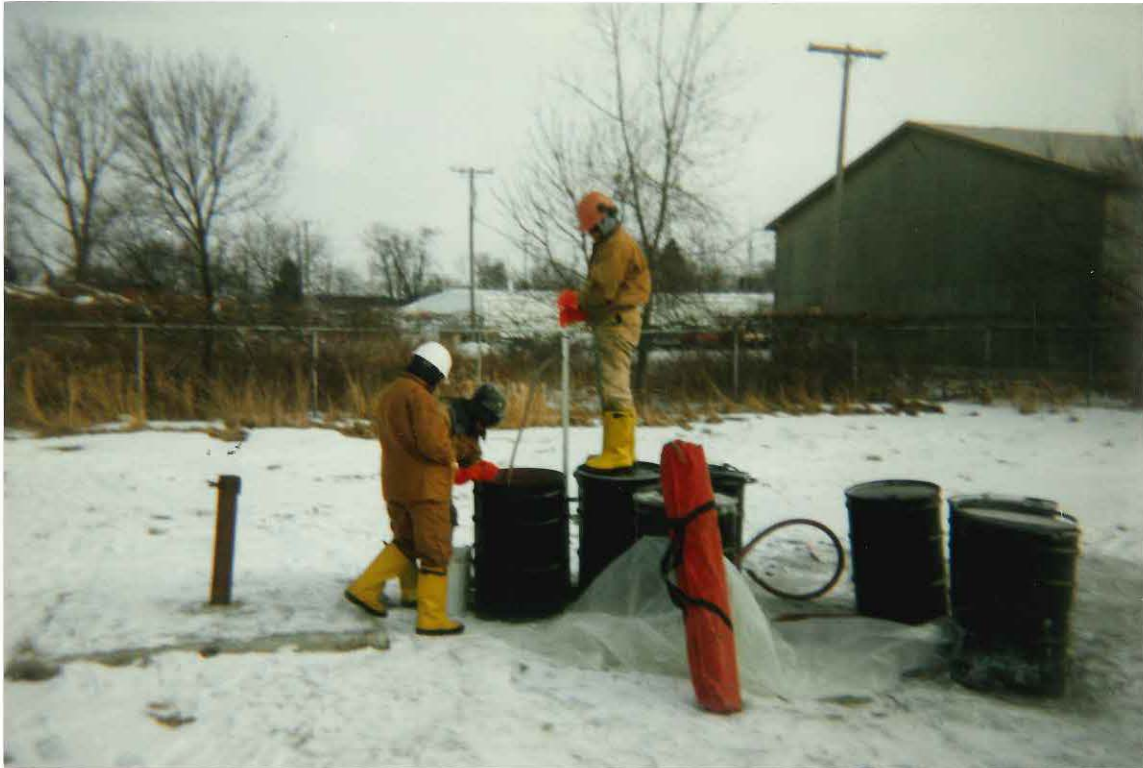
PHOTOGRAPH #57

On February 2, M&E observed the grid sampling of locations GB-15 to GB-23 with an MS/MSD sample collected at the GB-15 location. The well development proceeded slowly for the day. Monitoring well MW-BCK3 (Intermediate) was partially developed using the B-K pump, but the water would not clear. The well is to be developed by a Grundfos pump next week (2/7-2/9). Monitor well MW-J4 would not air lift develop so the Moyno pump on the rig was used to suction out the water. Well MW-B4 was developed dry after removing 5 gallons of water. Dames & Moore personnel decided to use a Grundfos pump to finish developing the well. Well MW-C3 was developed using the Moyno pump and a total of 300 gallons of water were removed. The development water was very murky and had an oily sheen along with a hydrocarbon odor to it. The odor smelled like Kerosene.

Drillers using Brainard-Killman (B-K) pump to develop MW-BCK3 (intermediate well).

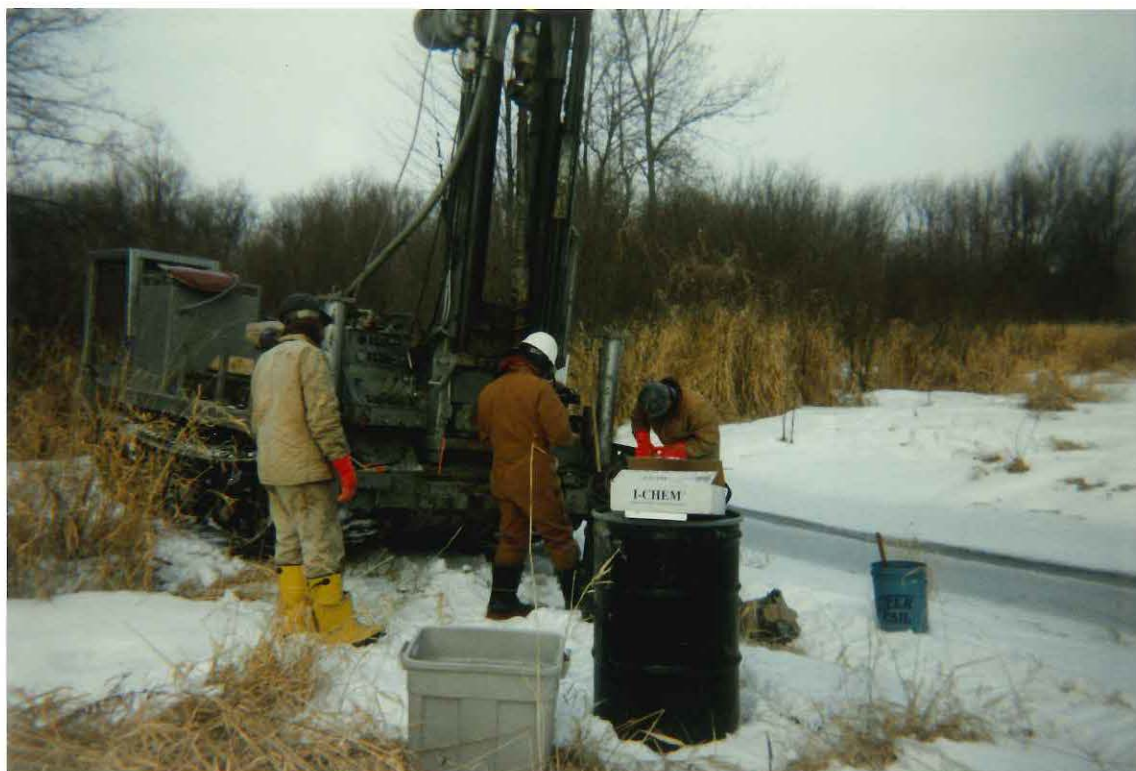
PHOTOGRAPH #58

Stanley Tools, Fowlerville, MI
2/2/94
1030
Dames & Moore conducting health & safety
monitoring at GB-17.

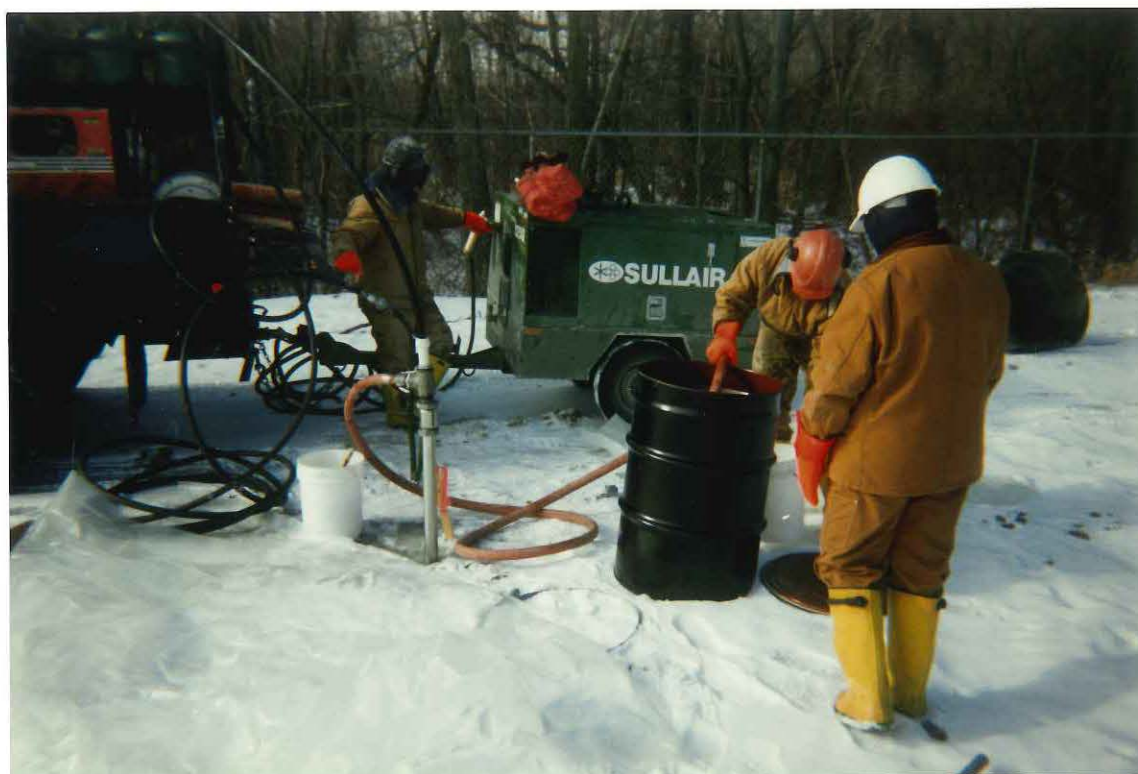
PHOTOGRAPH #59

LOCATION:	Stanley Tools, Fowlerville, MI
DATE:	2/2/94
TIME:	1130
SUBJECT:	Air surging MW-J4.

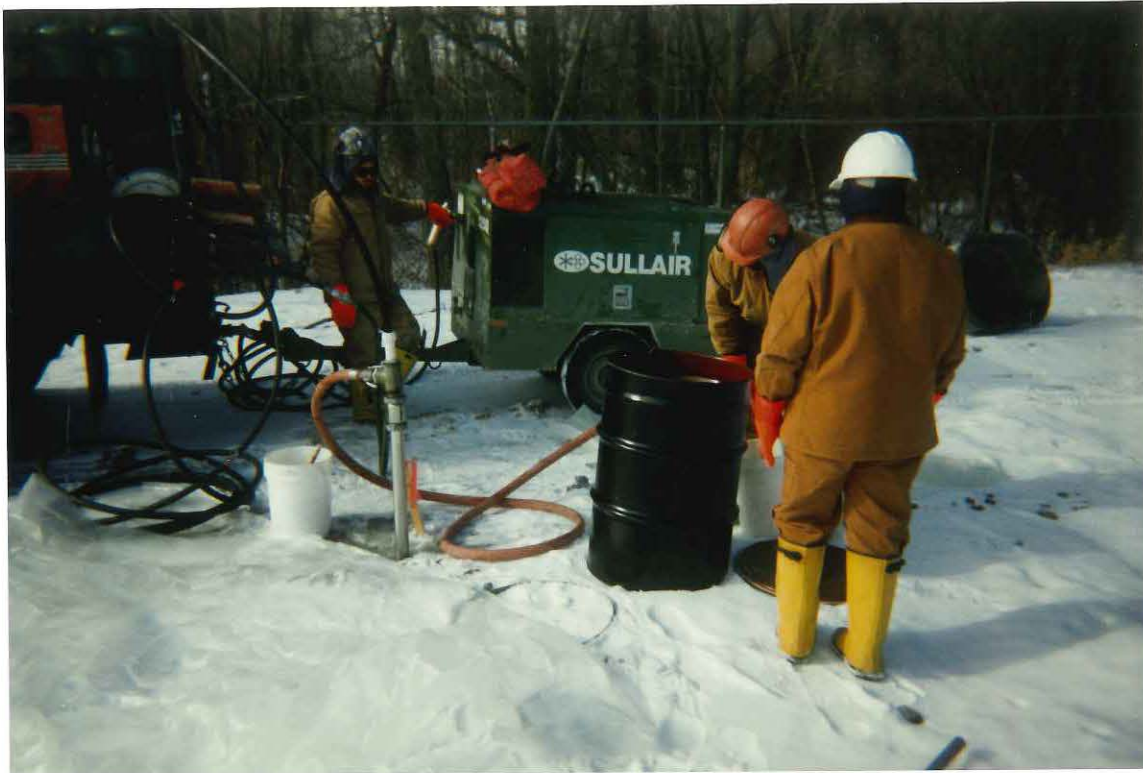
PHOTOGRAPH #60

LOCATION:	Stanley Tools, Fowlerville, MI
DATE:	2/2/94
TIME:	1130
SUBJECT:	Air surging MW-J4.

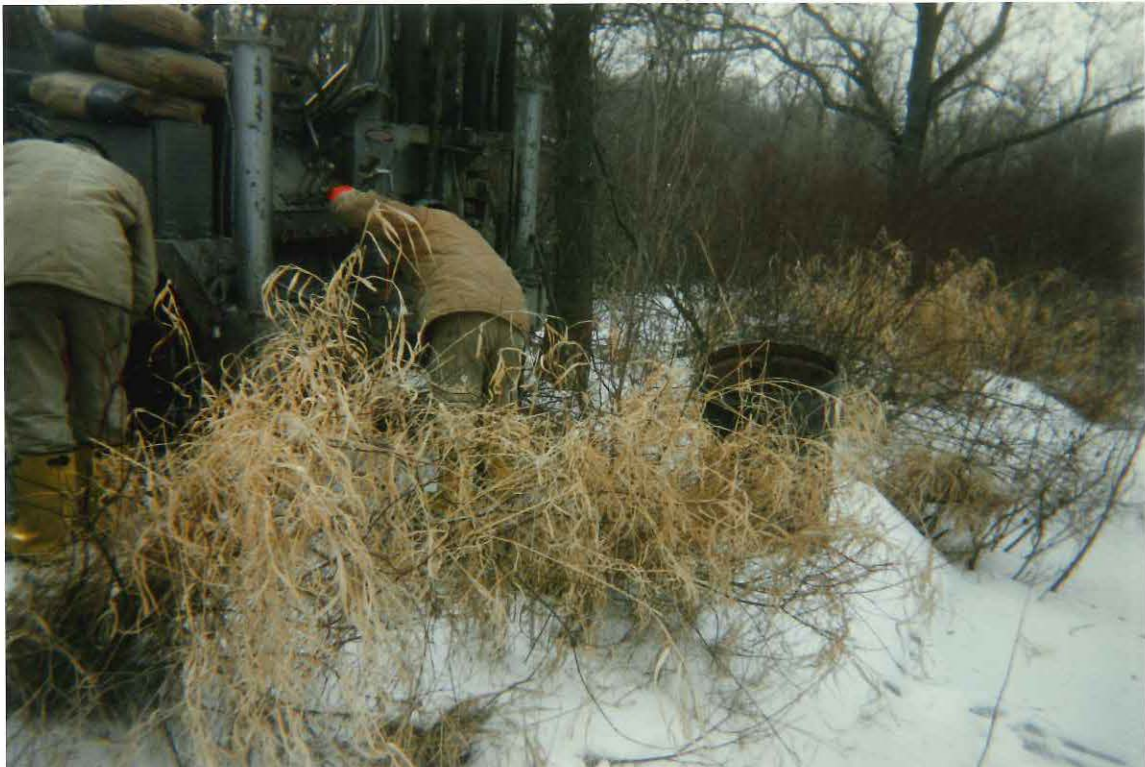
PHOTOGRAPH #61

LOCATION:	Stanley Tools, Fowlerville, MI
DATE:	2/2/94
TIME:	1330
SUBJECT:	Grid boring GB-18.

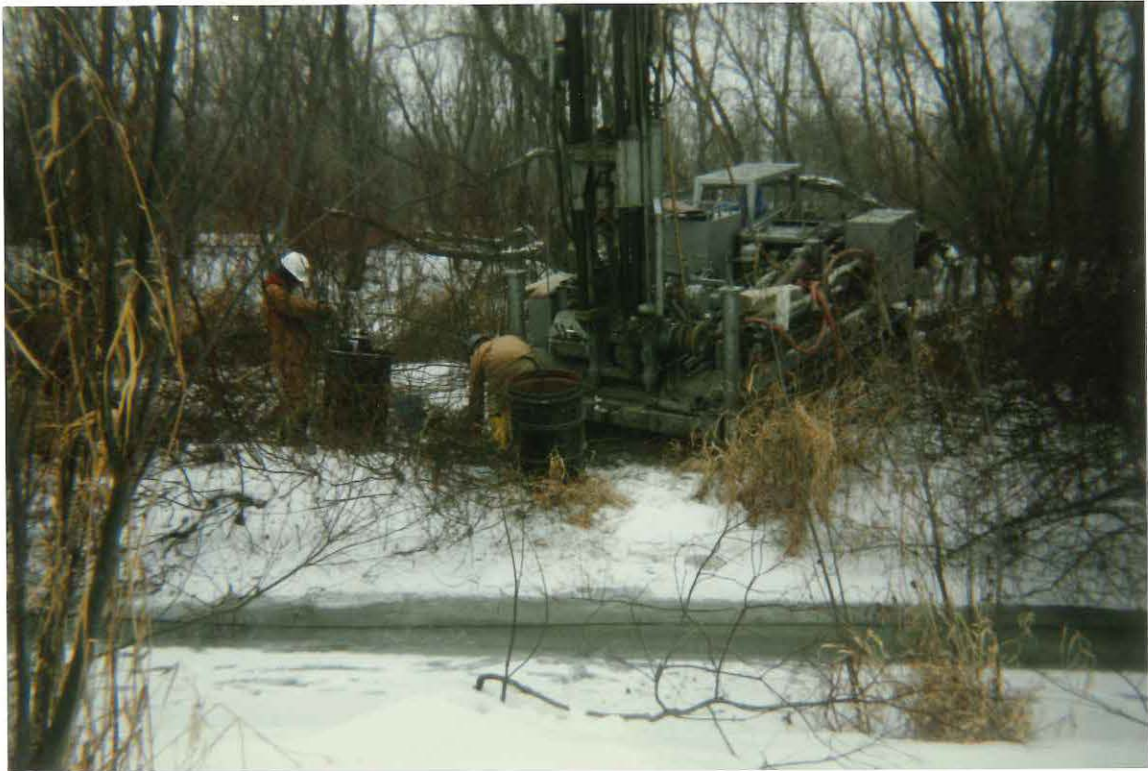
PHOTOGRAPH #62

LOCATION:	Stanley Tools, Fowlerville, MI
DATE:	2/2/94
TIME:	1430
SUBJECT:	Grid boring location GB-19, south bank of north drainage ditch.

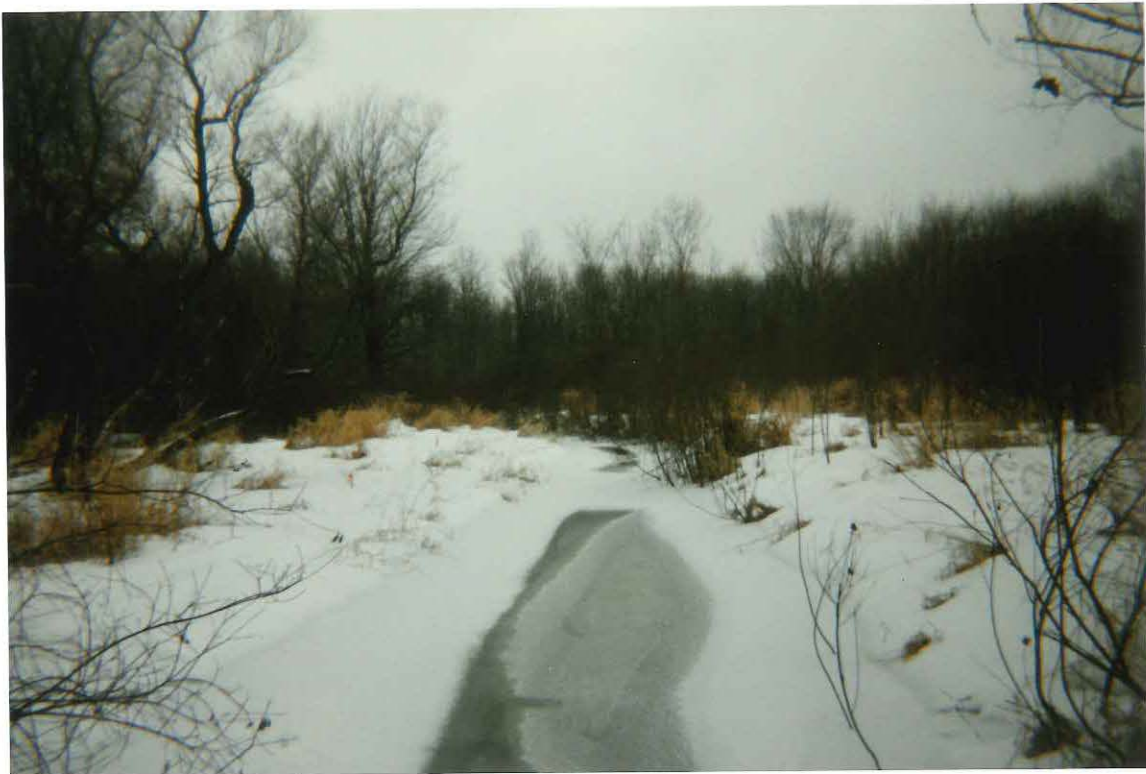
PHOTOGRAPH #63

LOCATION:	Stanley Tools, Fowlerville, MI
DATE:	2/2/94
TIME:	1432
SUBJECT:	Staked locations GB-21, -22 and -23 along south side of north drainage ditch, looking toward Red Cedar River.
